Tech Specs

Repair of Utility Cuts Using Interlocking Concrete Pavers

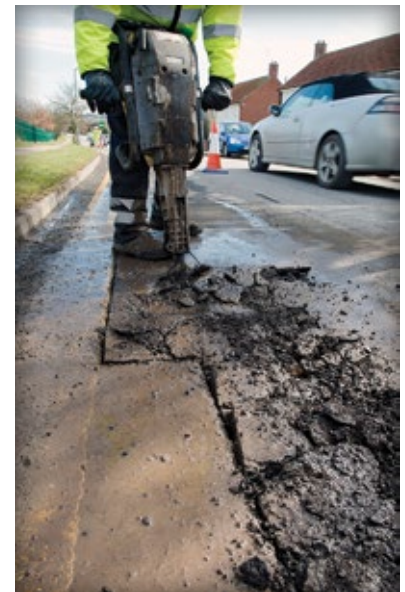
Figure 1. Repairs to utilities are a common sight in cities, incurring costs to cities and taxpayers.

North American cities have thousands of utility cuts made in their streets each year. Figure 1 shows a daily occurrence in most cities: repairs to underground utility lines for water, sewer, gas, electric, steam, phone, fiber-optic, or cable services. A sample is given below of the number of annual utility cuts in a few cities.

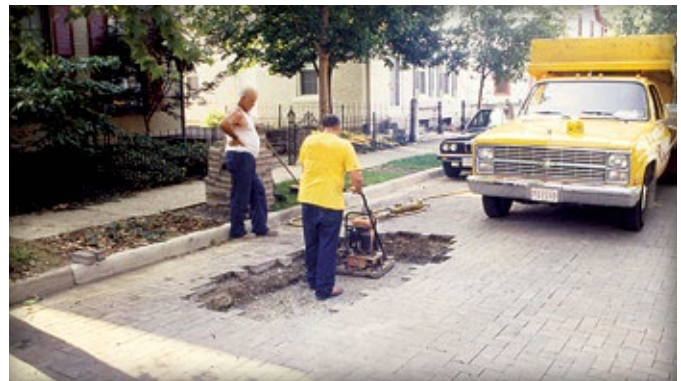
Figure 3. Compaction of the base

Figures 2, 3, 4, 5 and 6 show the process of repair and illustrate the continuity of the paver surface after it is completed. The reinstated units are knitted into existing ones through the interlocking paving pattern and sand filled joints. Besides providing a pavement surface without cuts, the joints distribute loads by

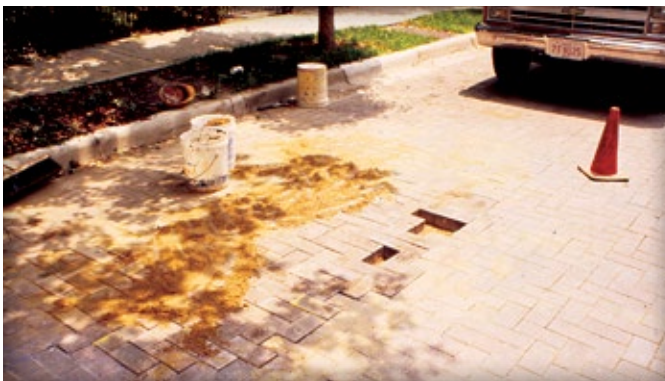
Figure 4. Reinstatement of the pavers, bedding and joint sand

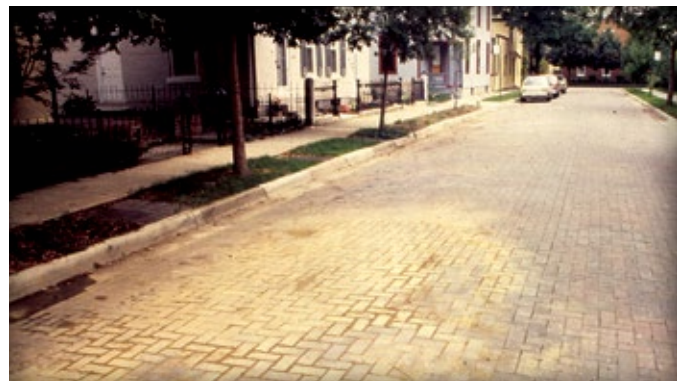
Figure 5. The final paver surface is continuous. There are no cuts or damage to the pavement.

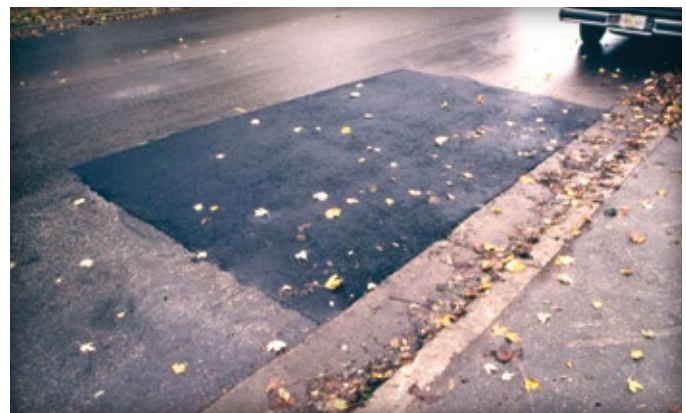
Figure 7. Pavement damage from settlement and shrinkage of cold patch asphalt.

Figure 7 shows the result of settlement and shrinkage of the cold patch asphalt in a London, Ontario, utility cut. The change in dimensions causes the edge of the cut asphalt to deteriorate, and settlement decreases riding quality.

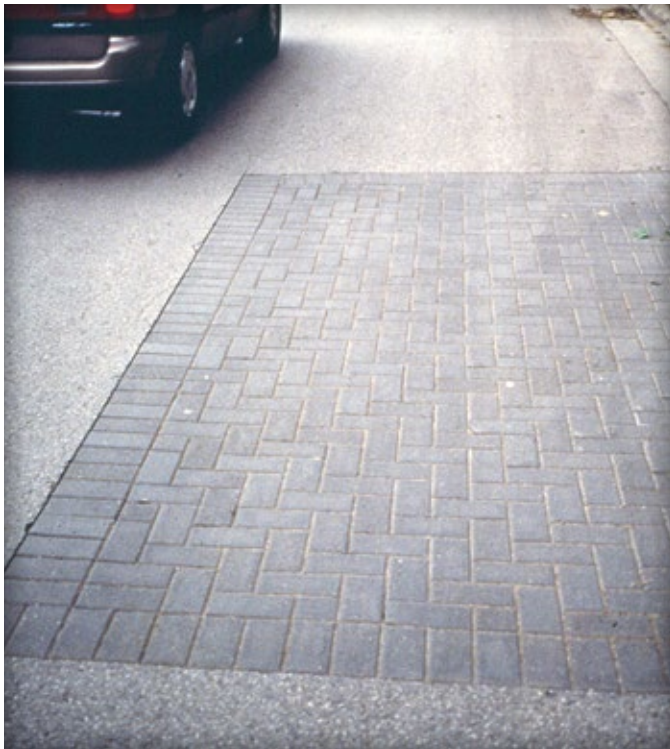
Figure 8. Utility cut repair in a residential area in London, Ontario.

Concrete pavers on low density concrete fill have been successfully used as a replacement for cold patch asphalt (Figures 8 and 9). They were first used as a temporary repair with the intent of being removed in the spring. However, the pavers performed so well that the City of London left them in place indefinitely. Several repairs were in streets subject to heavy truck traffic, as well as residential streets. Costs were less than using cold patch asphalt.

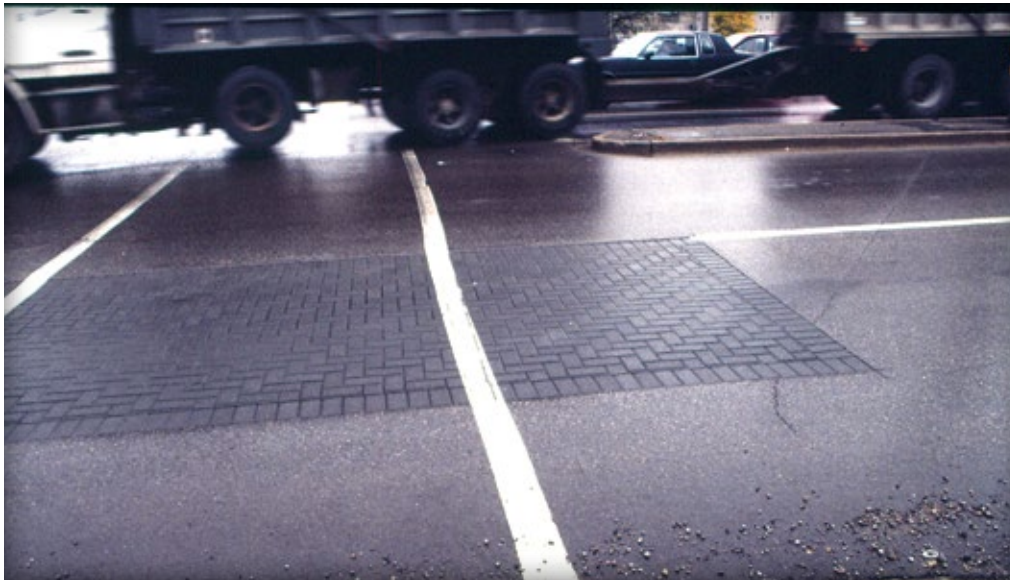
Figure 10. A patch of pavers in a heavily trafficked intersection in London, Ontario

to match the appearance of the asphalt so there would be no substantial differences in appearance. Figure 10 shows such a patch of pavers blending with the surrounding pavement.

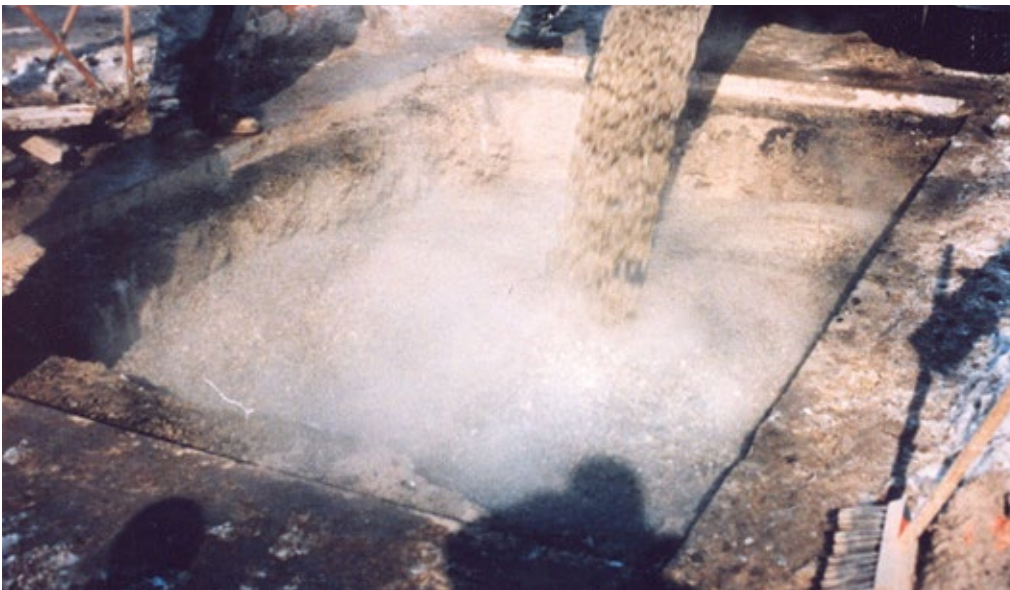
Figure 11. Low density concrete fill (unshrinkable fill) poured into a utility trench from a ready-mix concrete truck.

Unshrinkable fill poured into the trench is shown in Figure 11. The fill flows into undercuts, under the edge of the cut asphalt (providing additional support), and in places where the soil or base has fallen from the sides of the trench. These places are normally impossible to fill and compact with aggregate base or backfill material.

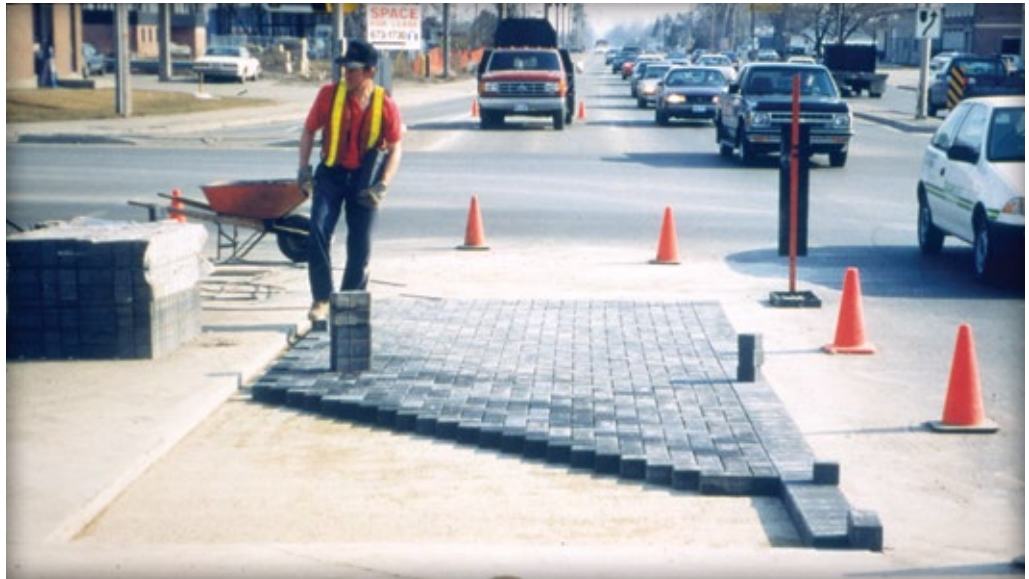
Figure 12. Pavers are laid in a 90 degree herringbone pattern between the border courses.

ers [nominally 4 in. by 8 in. (100 mm x 200 mm)] should be placed against the cut asphalt sides as a border course. They should be placed in a sailor course, i.e., the long side against the asphalt. No cut paver should be smaller than one third of a unit. Place pavers between the border course in a 90 degree herringbone pattern (Figure 12). Joints between pavers should be between $\frac{1}{16}$ and $\frac{5}{16}$ in. (2 to 5 mm). Compact the pavers with a minimum 5,000 lbf (22 kN) plate compactor. Make at least four passes with the plate compactor. A small test area of pavers may need to be compacted to check the amount of settlement. The bedding sand thickness should

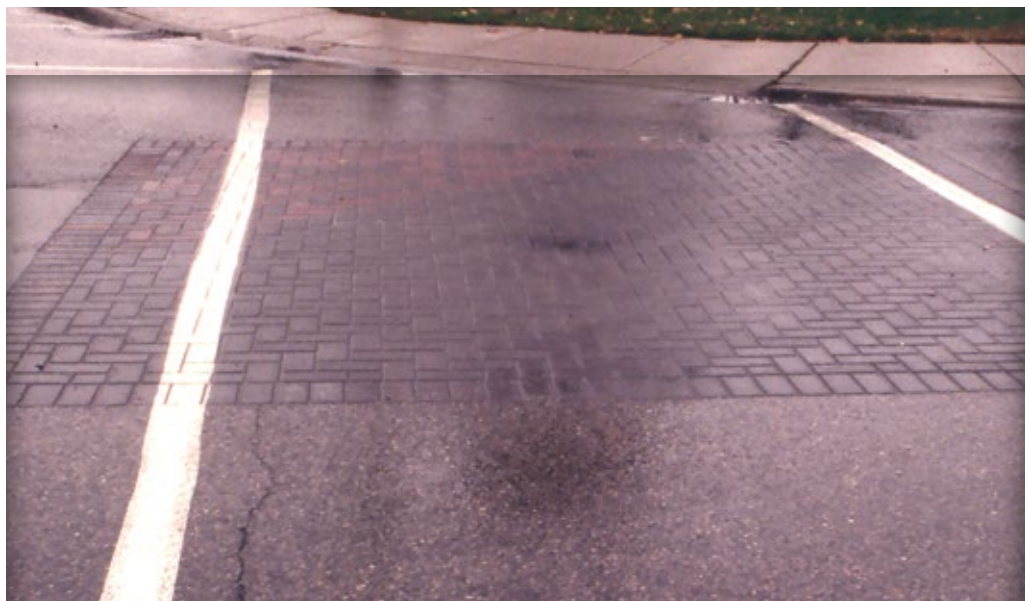
Figure 13. Concrete pavers in utility cuts can be painted as any other pavement.

Spread, sweep and compact sand into the joints. The joint sand is typically finer than the bedding sand, and should conform to the grading requirements of ASTM C 144 (11) or CSA A179 (10). The joints must be completely full of sand after compaction. Remove excess sand and other debris. The pavers may be painted with the same lane, traffic, or crosswalk markings as any other concrete pavements (Figure 13).
